ACTION: Supplemental notice of proposed rulemaking (NPRM); Reopening of the comment period.

[Docket No. 92-CE-63-AD]

Airworthiness Directives; Piper Aircraft Corporation PA-25 Series Airplanes

Piper Aircraft Corporation: Docket No. 92-CE-63-AD. Supersedes AD 93-21-12, Amendment 39-8763.

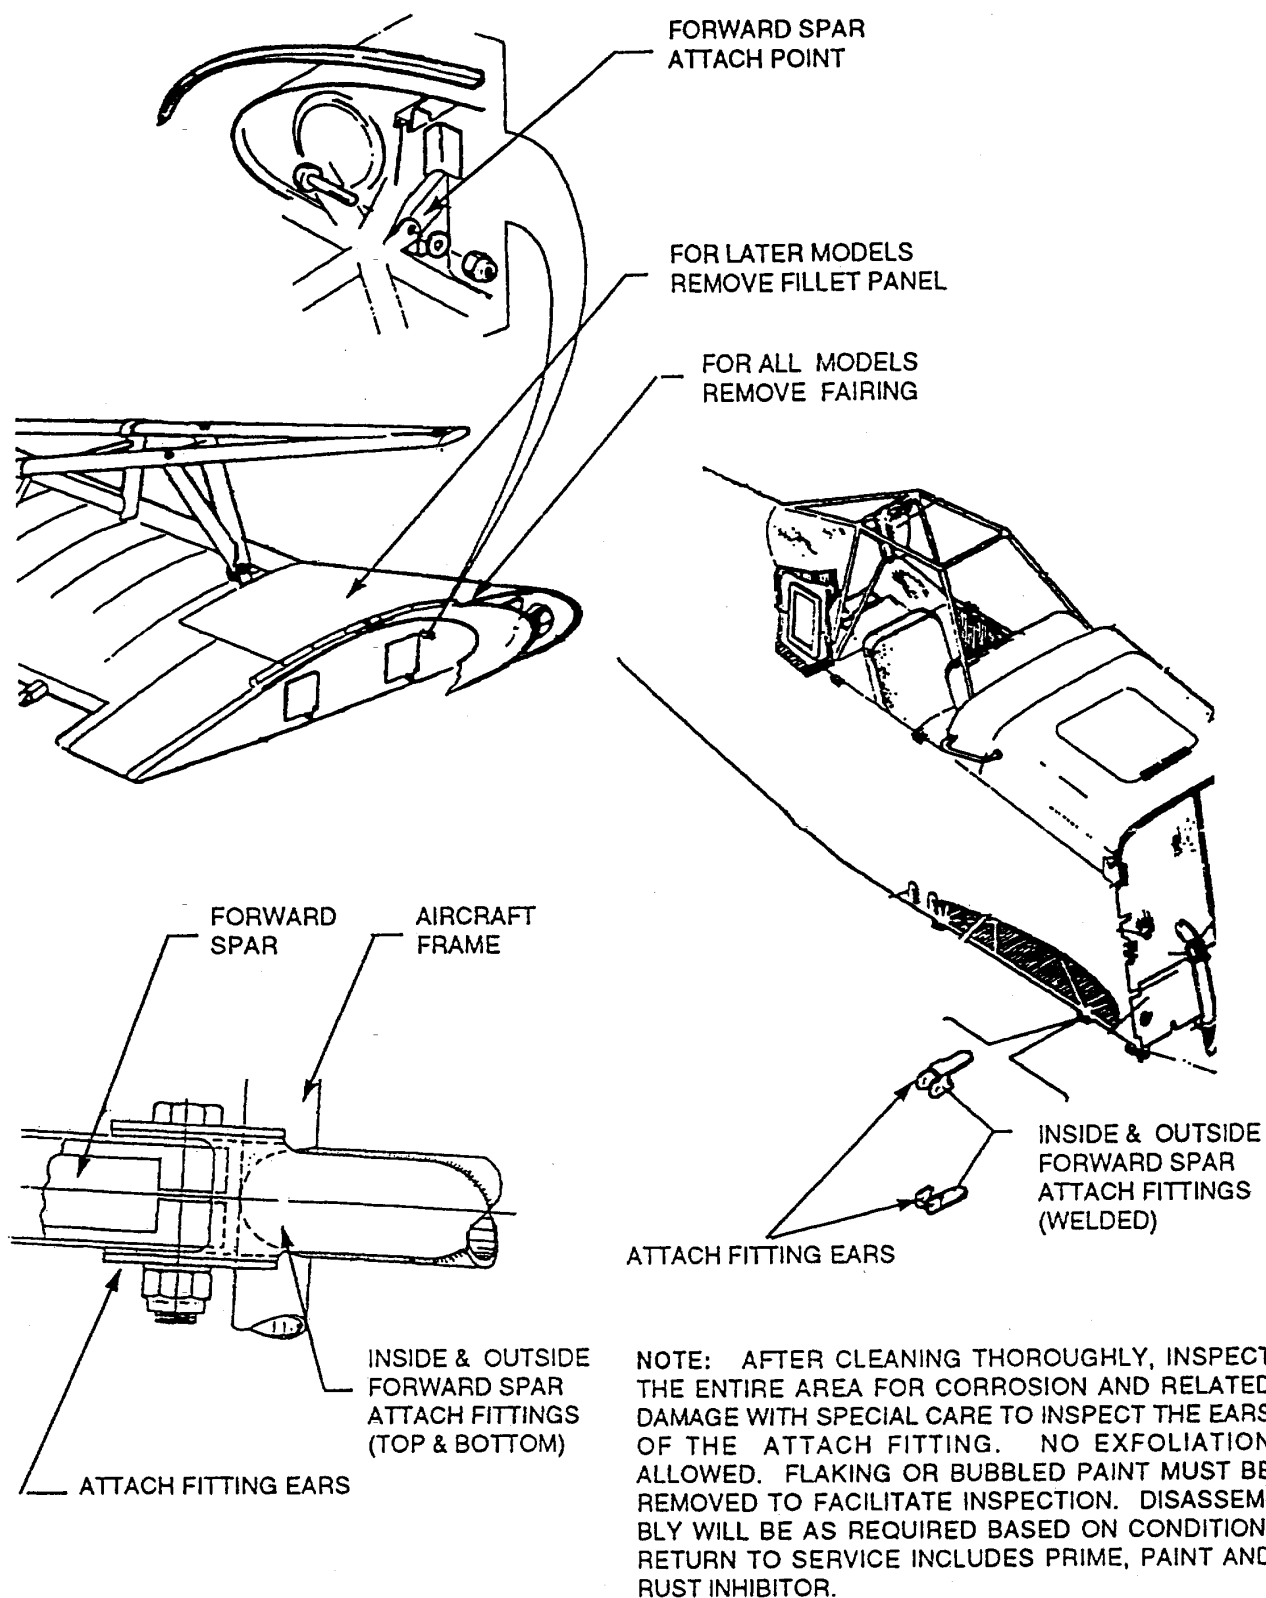
FIGURE 1

PA-25
Side View of the Front Wing Fitting
and Landing Gear Fittings

(a) Gain access to the left and right wing forward spar fuselage attach fittings by removing the screws retaining the wing fairing. Dismantle the wing fillet by removing the screws on the aft edge top and bottom and removing the wing fairing (see Figure 1 of the Appendix to this AD).

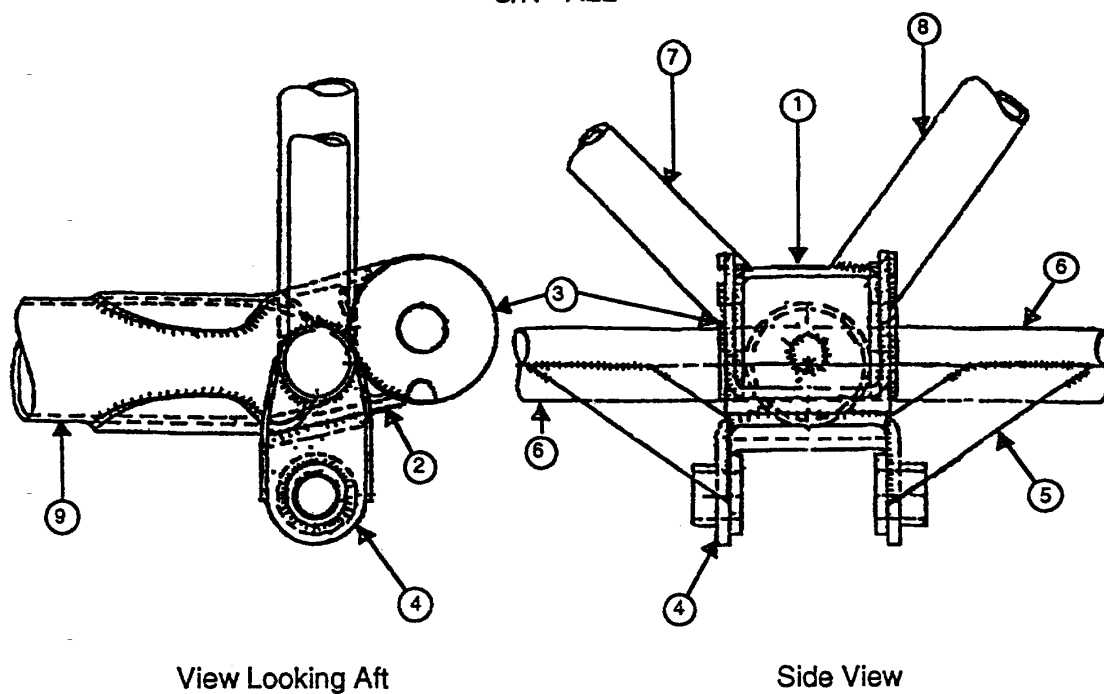
Figure 3a

PA-25-150
S/N - ALL
Front Wing Spar Attachment-Fittings and Tubes

1. Add couplant to the outside inspection surface (Refer to Figures 3a,

2. Add couplant to the inside inspection surface (Refer to Figures 3a, 4a and 5a, as applicable). Add the appropriate gain to obtain the backwall echo from the inspection surface. To assure proper coupling to the test sample, twist the probe (clockwise and counter-clockwise with a 45-degree twist). During the articulation of the probe, observe the A-trace on the screen and stop the probe twist at the point of adequate back surface signal amplitude to trigger the thickness gate on the first half-cycle. Measure and record the thickness. Repeat the above process at eight equally-spaced locations around the surface.

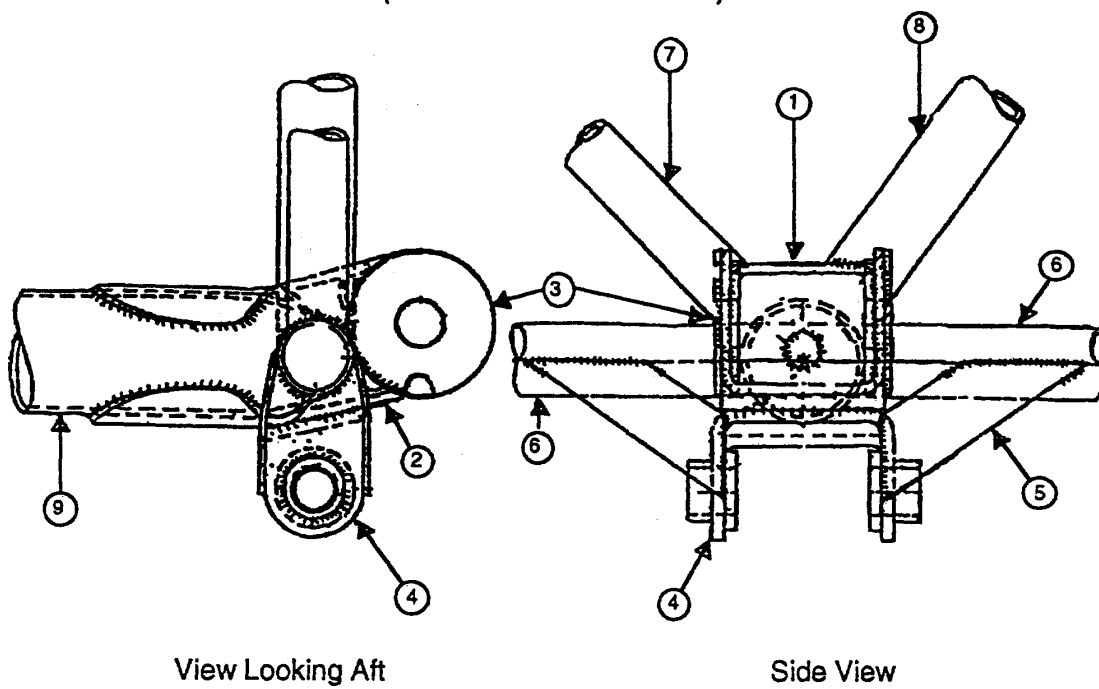
Figure 4a

PA-25-235
S/N - 25-2000 to 25-2985
Front Wing Spar Attachment-Fittings and Tubes

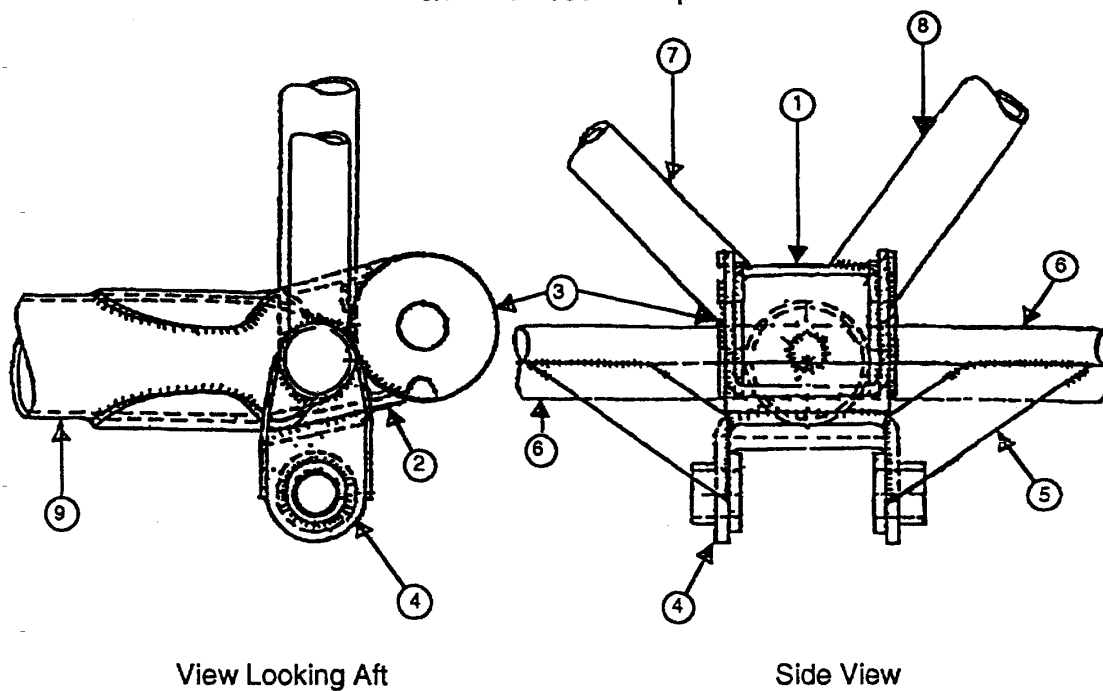
Figure 5a

PA-25-235,-260
S/N - 25-2986 and Up
Front Wing Spar Attachment-Fittings and Tubes
